Review of Environmental Factors

Gap Park Tramway Footpath

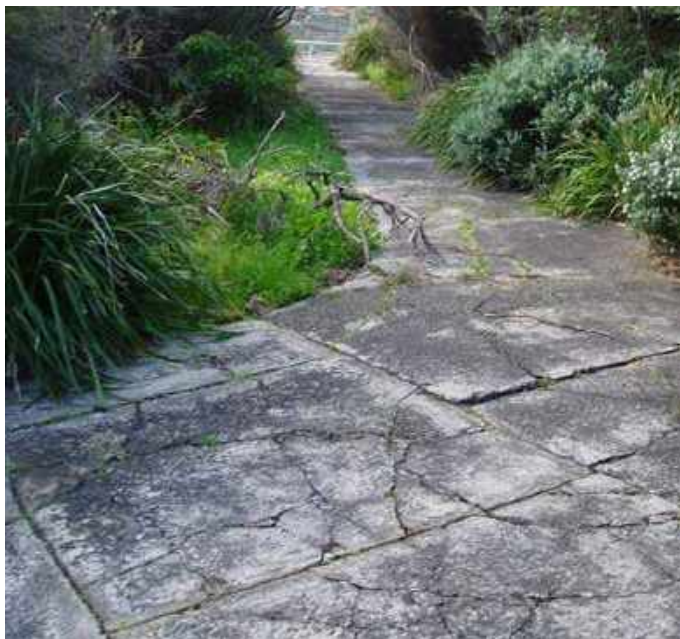
Concrete with exposed aggregate is used throughout the park, and was selected because of its durable nature. The concrete of The Gap viewing area is particularly distinctive, and visually articulate the harsh natural conditions of the site. The remnant original concrete paving from the former “Gap Loop” tram station to The Gap viewing area also tells its own tale of the former access to the site. In other areas, such as the littoral rainforest part of Jacob’s Ladder, the concrete was textured to provide grip. Parts of the existing paving, such as is evident along the coastal path, are lifting and require attention.

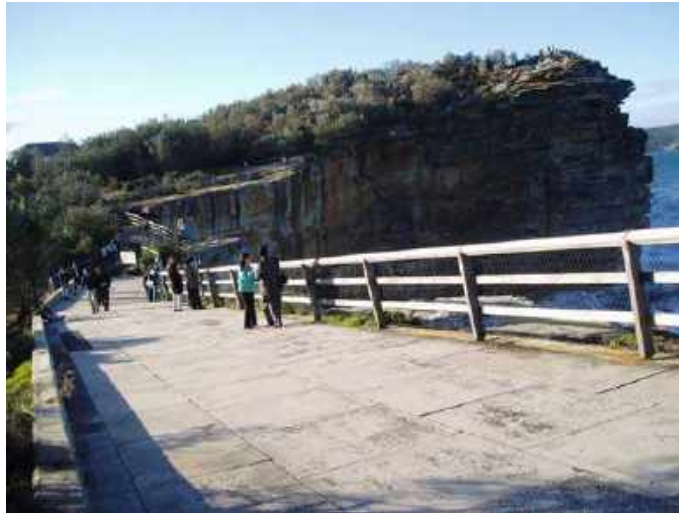
The Gap viewing area

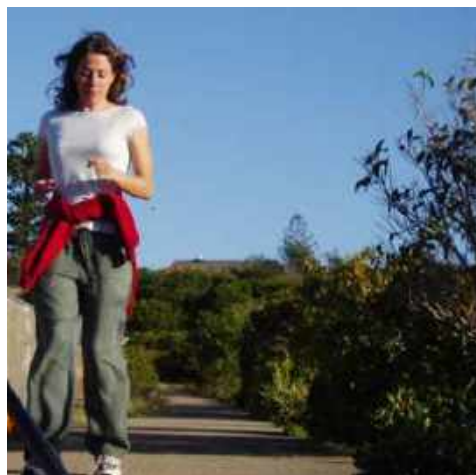
Gap Park user on coastal pathway

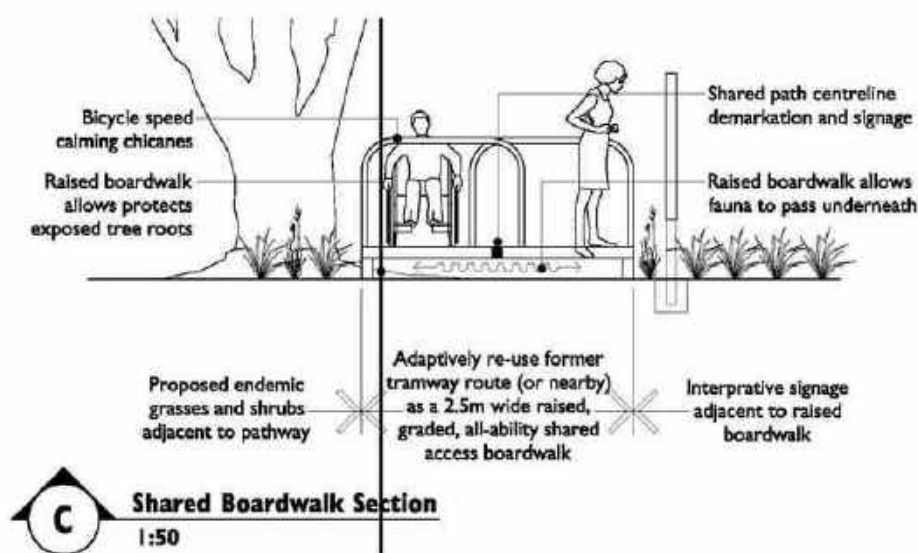
Interpretive signage to be installed, regarding the rich tram history (operated 1903 - 1960).

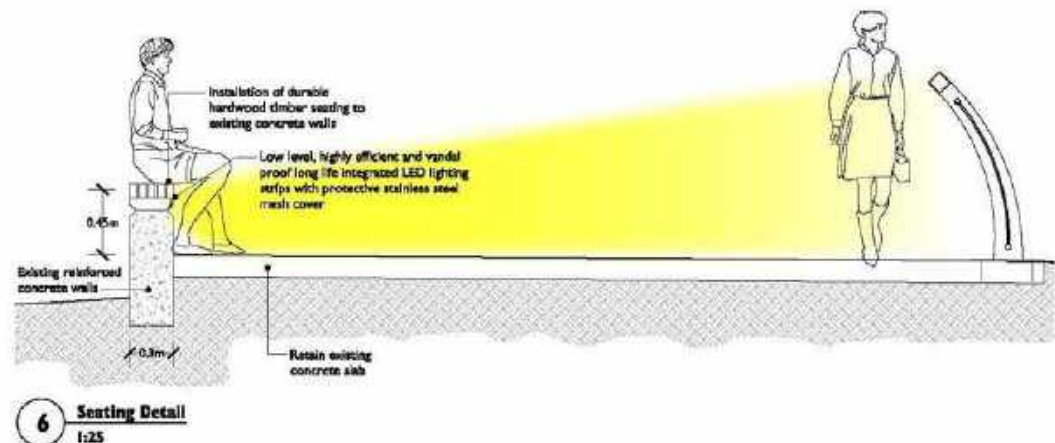
3.8.2 Safety Telephone

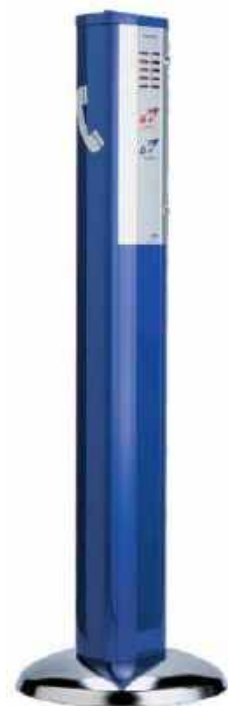
- Programmable send and receive numbers with no charge for call
- One to three push button(s) to programmed numbers (e.g. 000 or local police)
- Hands-free speaker, with built in microphone
- Internal battery with charging options (solar, mains)
- Digitally stored announcements
- Illuminated button option
- Vandal-resistant aluminum housing, with dual high security locks
- All weather protection rating

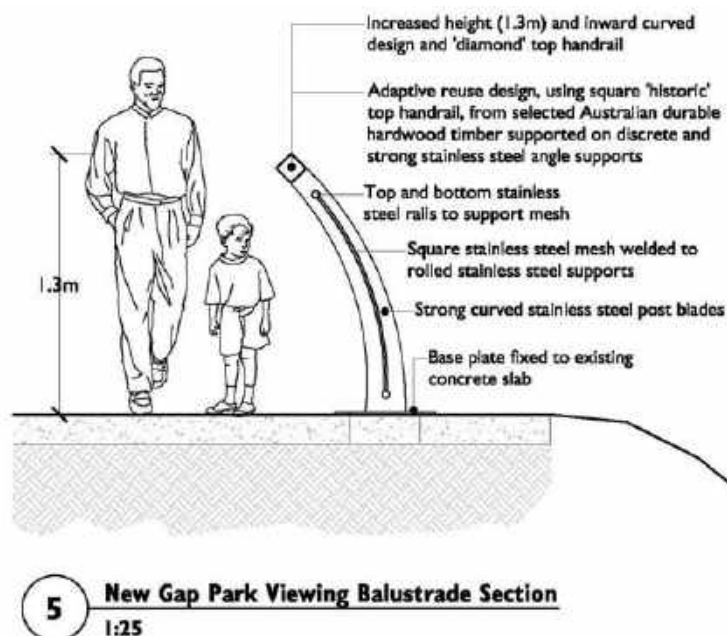
Balustrades are to be installed at the key lookout areas to the north and south of the park, at the main viewing locations. The curved vertical blades reflect nautical symbolism, while allowing for maximum visual transparency. They are curved inwards to deter climbing, but if the fence is scaled, it is possible to climb back over from the sea-cliff side. The diagonal timber top handrail is in keeping with historical Australian coastal handrail theme. In addition, the fence will be in-filled with welded stainless steel square mesh, to further deter climbing.

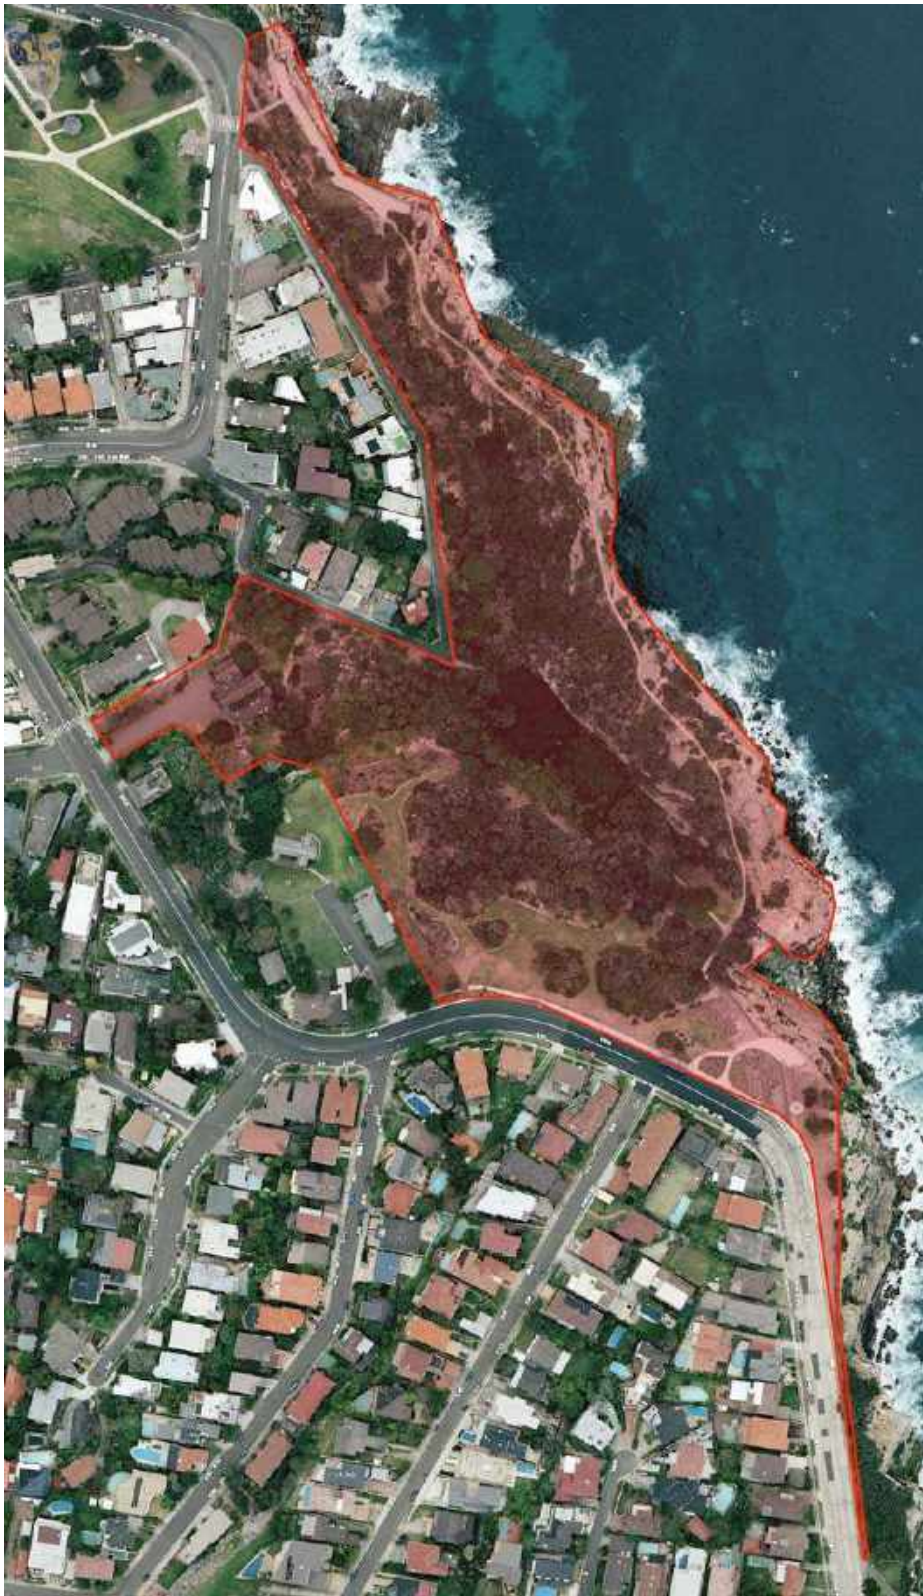
Figure 1 - Location Plan (study area is shaded red). *Source: Woollahra Municipal Council*

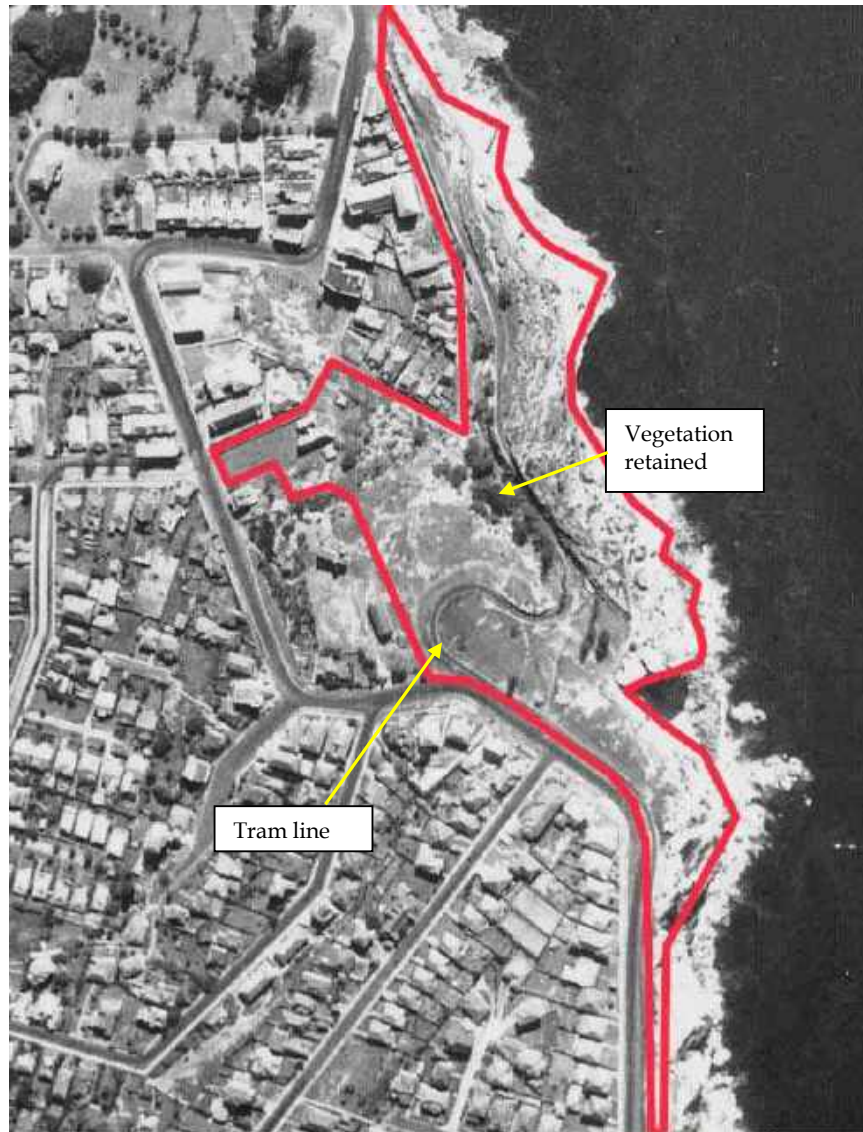
Figure 3 - 1943 Aerial Photograph of the Gap Park (outlined in red) showing vegetation removal in the Gap Park during World War II. Note also the position of the tram line. Source: Roads and Traffic Authority NSW.

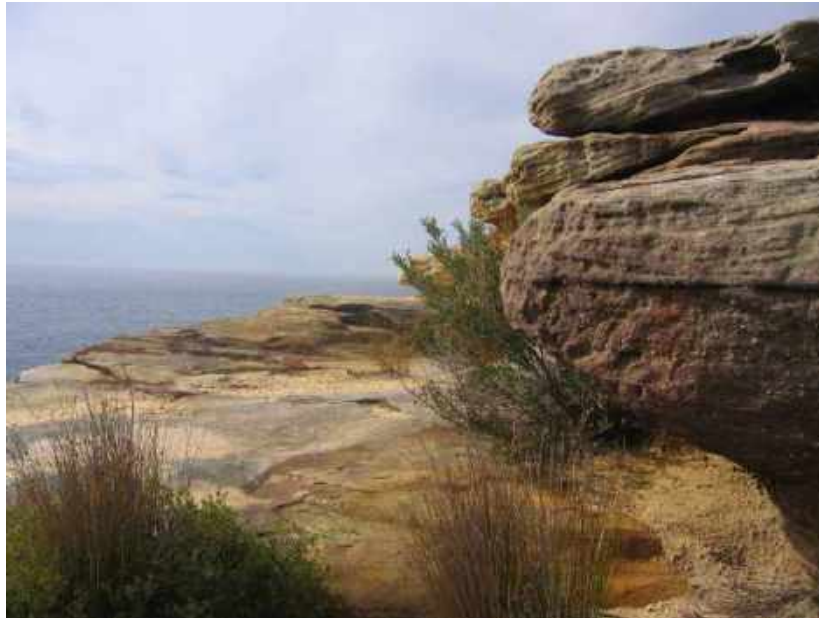
Figure 4: Exposed Hawkesbury sandstone, Gap Park.

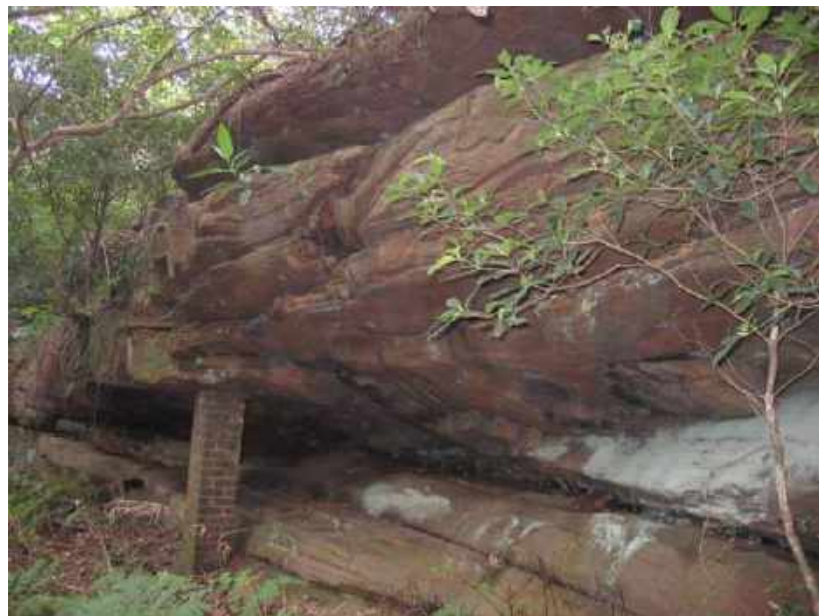
Figure 5: Exposed Hawkesbury sandstone with caves, Gap Park.

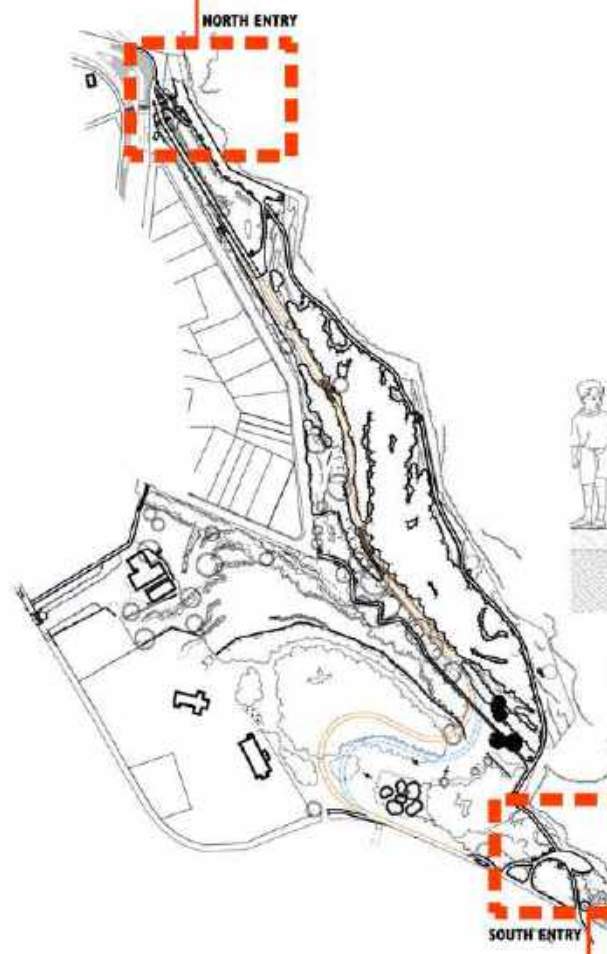
- 3 New Gap Park Viewing Balustrade Elevation**
1:25
- Increased height (1.3m) and inward curved design and 'diamond' top handrail
 - Adaptive reuse design, using square 'historic' top handrail, from selected Australian durable hardwood timber supported on concrete and strong stainless steel angle supports
 - Top and bottom stainless steel rails to support mesh
 - Square stainless steel mesh welded to rolled stainless steel supports
 - Strong curved stainless steel post blades
 - Base plate fixed to existing concrete slab

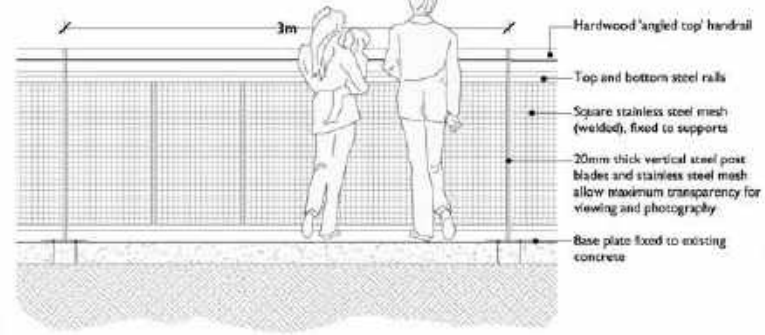
- 3.0 Proposed Fencing at Key Locations**
- Curved vertical blades with nautical symbolism, also allowing for maximum frontal transparency
 - Diagonal top handrail, in keeping with coastal theme
 - Welded, stainless steel square mesh
 - Curved inwards to deter climbing

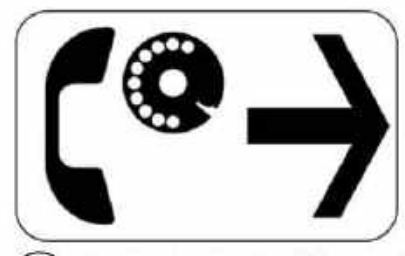
4 Safety Telephone Directional Sign Example

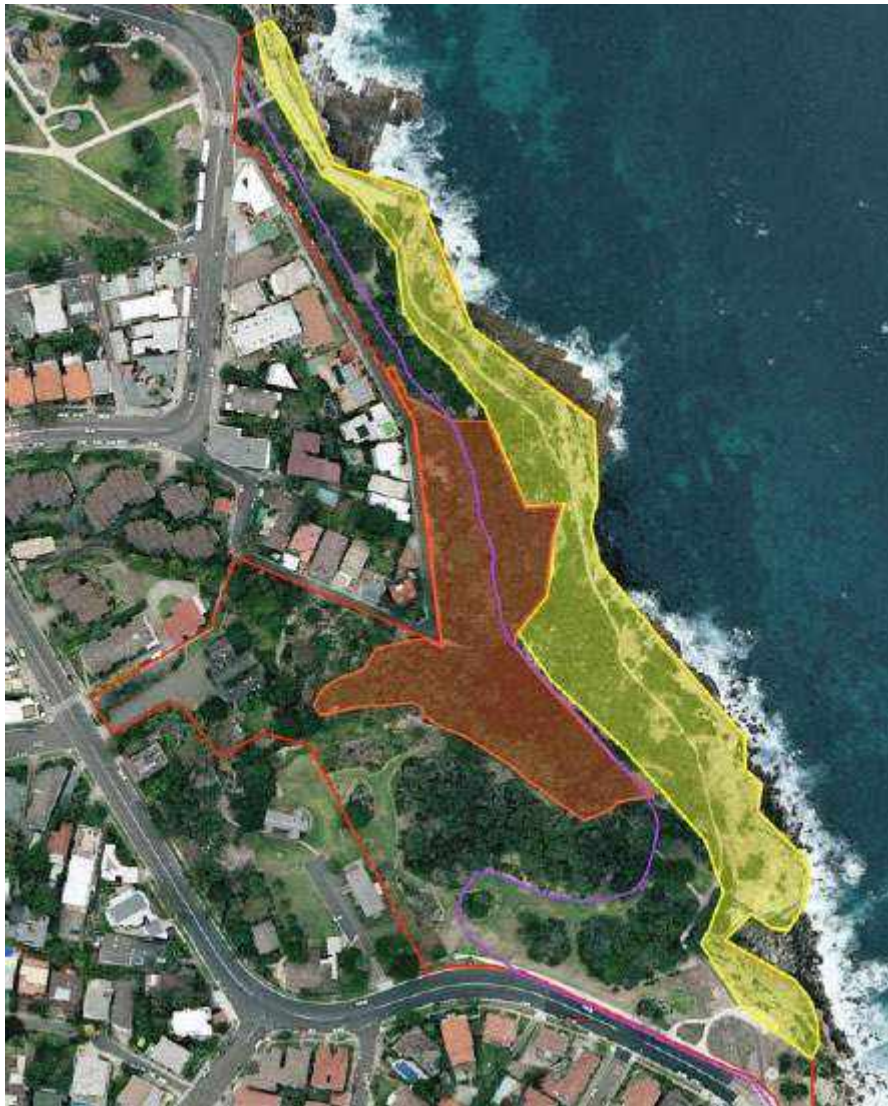
*Aerial photograph showing zones of archaeological potential
(Source: AHMS Preliminary Archaeological Investigation, August 2007)*

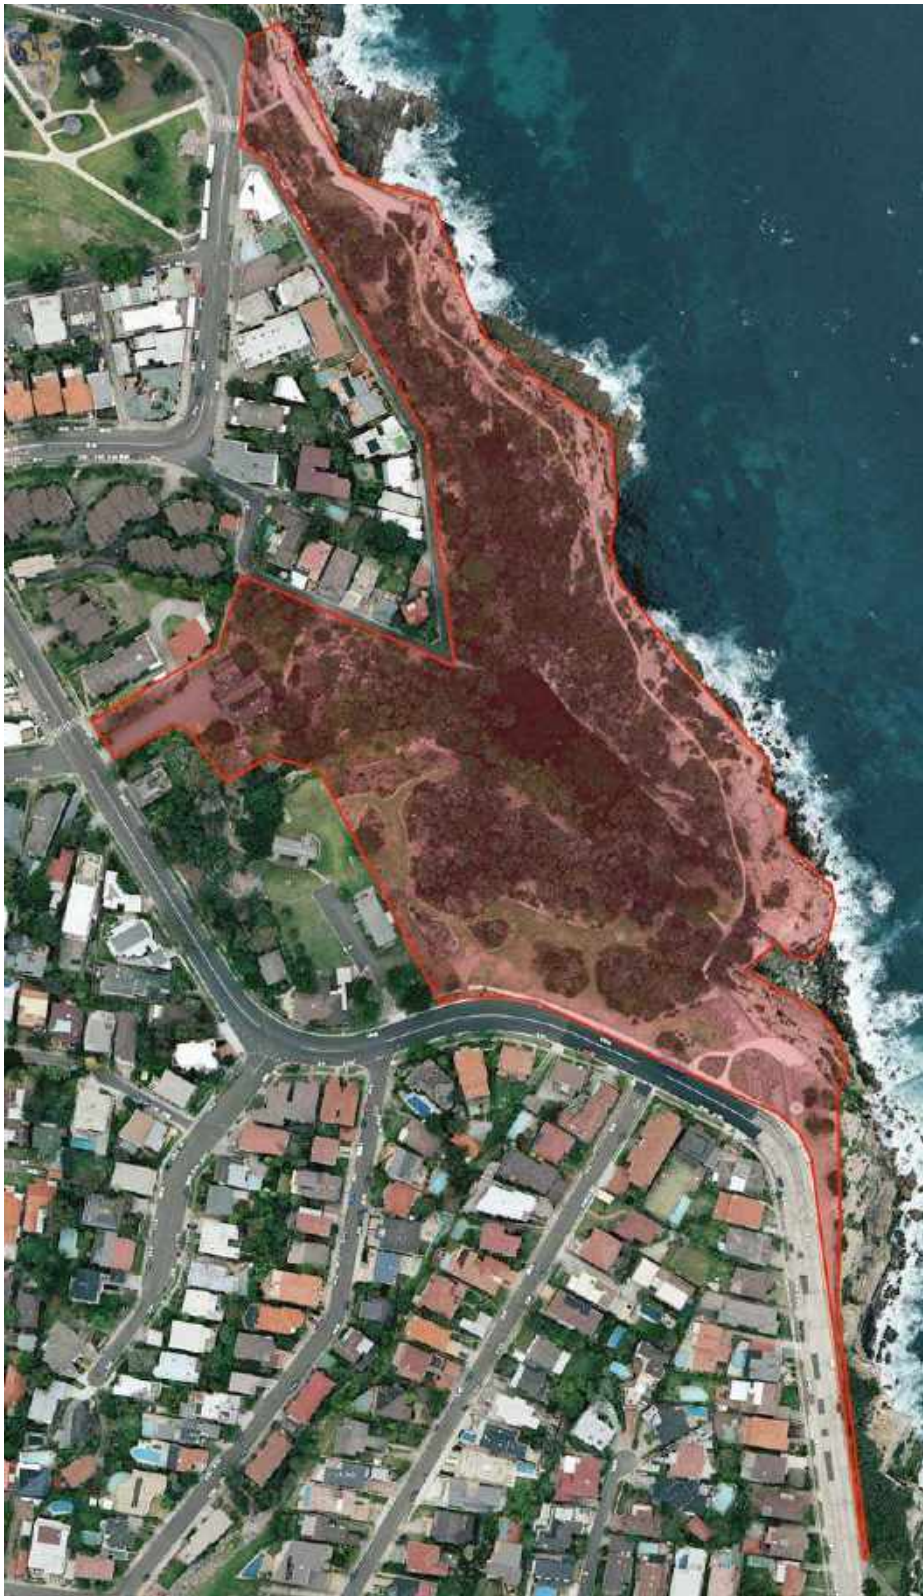
Figure 1 - Location Plan (study area is shaded red). *Source: Woollahra Municipal Council*

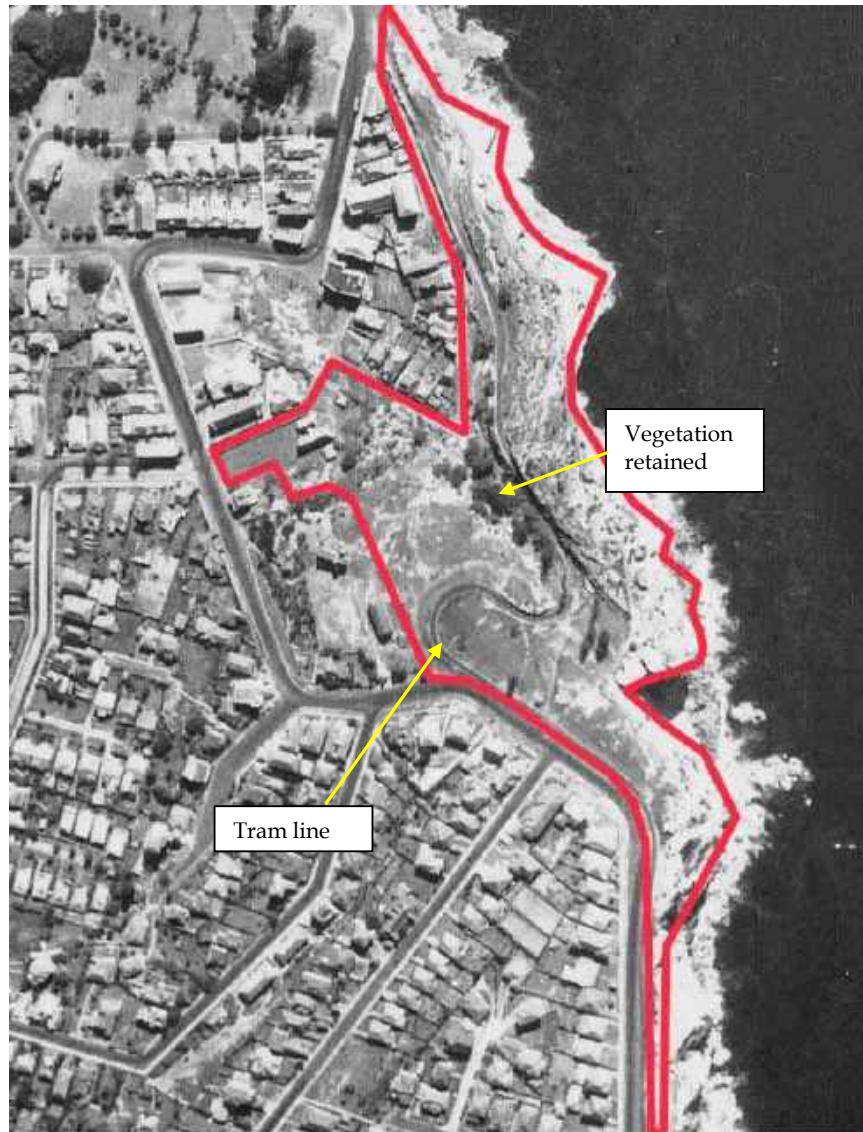
Figure 3 - 1943 Aerial Photograph of the Gap Park (outlined in red) showing vegetation removal in the Gap Park during World War II. Note also the position of the tram line. Source: Roads and Traffic Authority NSW.

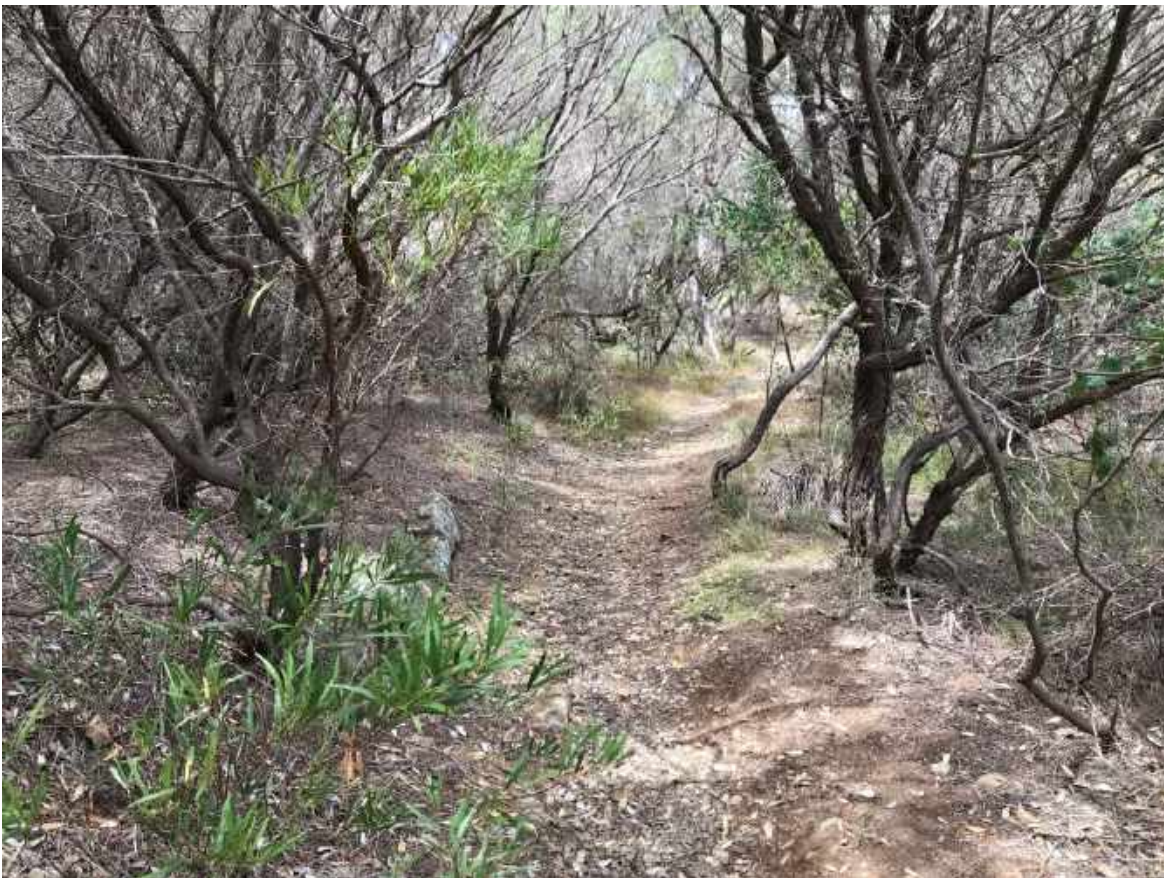
Typical conditions of existing bushland track

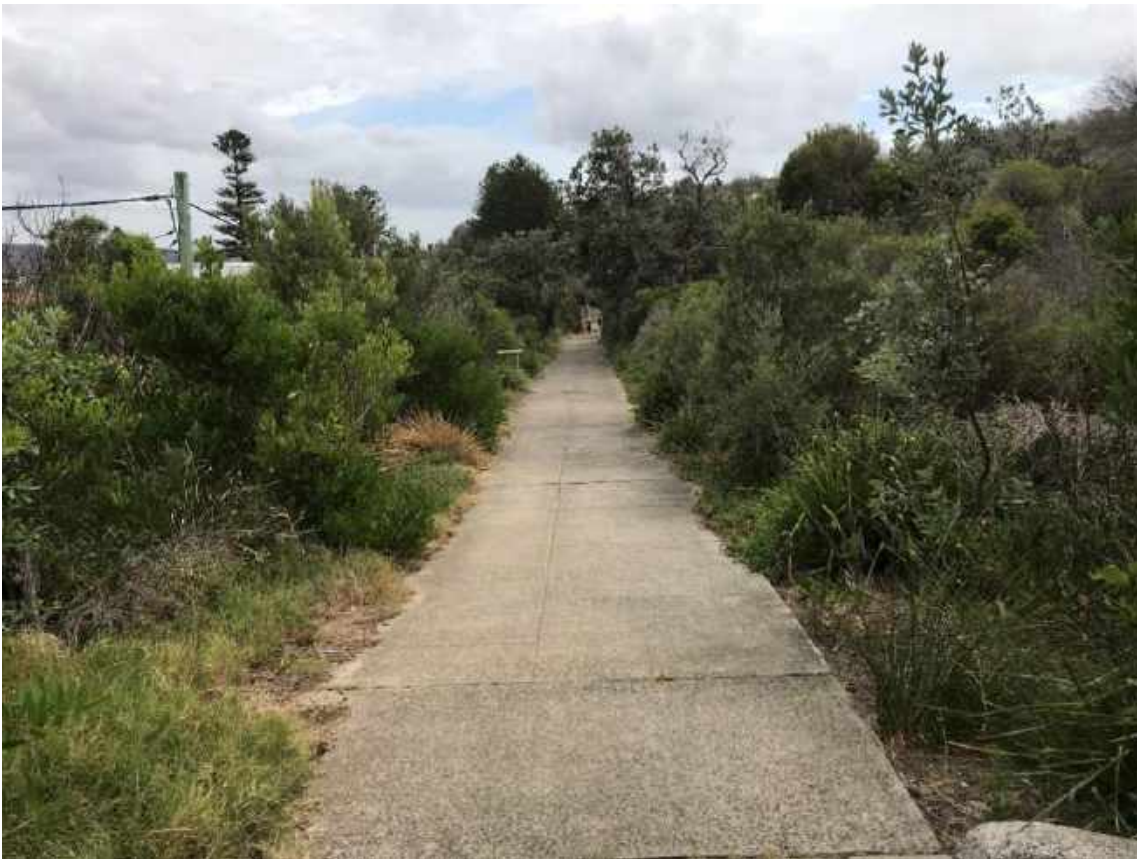
Existing path along tram route from 'Gap Loop' towards Military Road

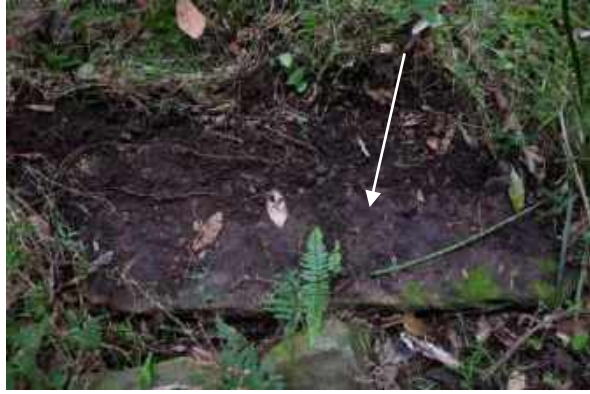
Figure 5-24. Detail of sandstone boundary stone partially covered in decayed leaf matter.

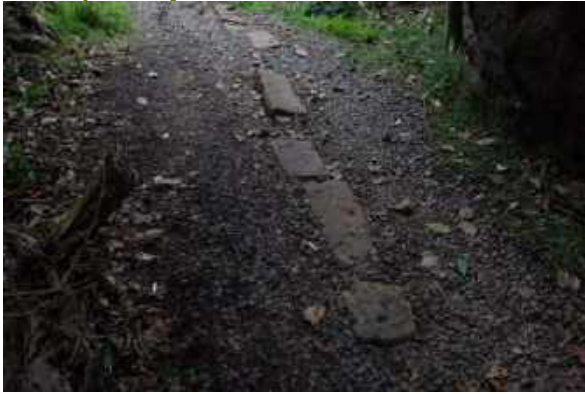
Figure 5-25. Example of sandstone boundary.

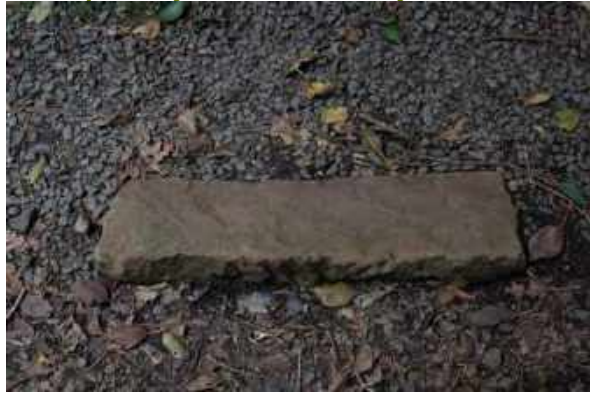
Figure 5-26. Detail of loose sandstone boundary stone.

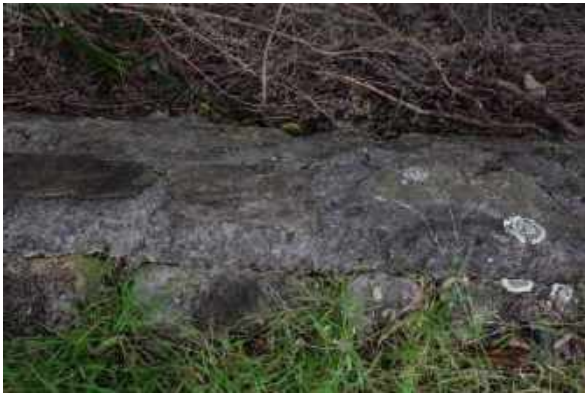
Figure 5-27. View west looking down slope from the former tramway showing a concrete and stone retaining wall.

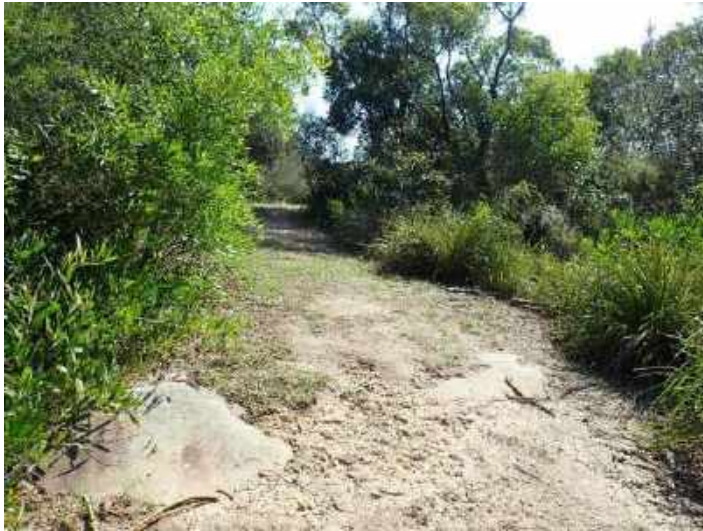
Figure 7. View west over filled area at the southern end of the proposed path.

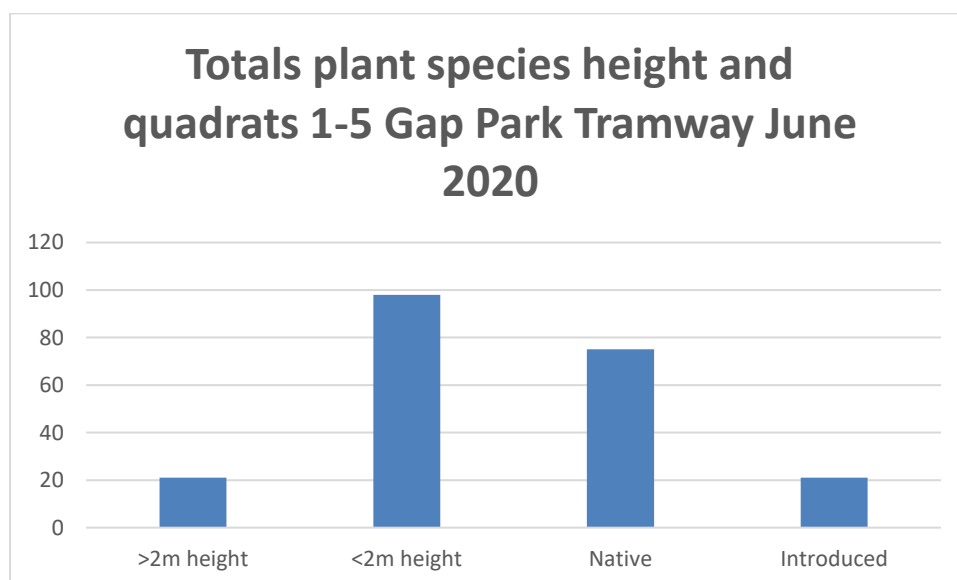
Figure 1 Total number of plant height species in all 5 quadrats Gap Park Tramway site
